2017 Robles Fish Passage Facility Progress Report

Casitas Municipal Water District
1055 Ventura Avenue
Oak View, California 93022

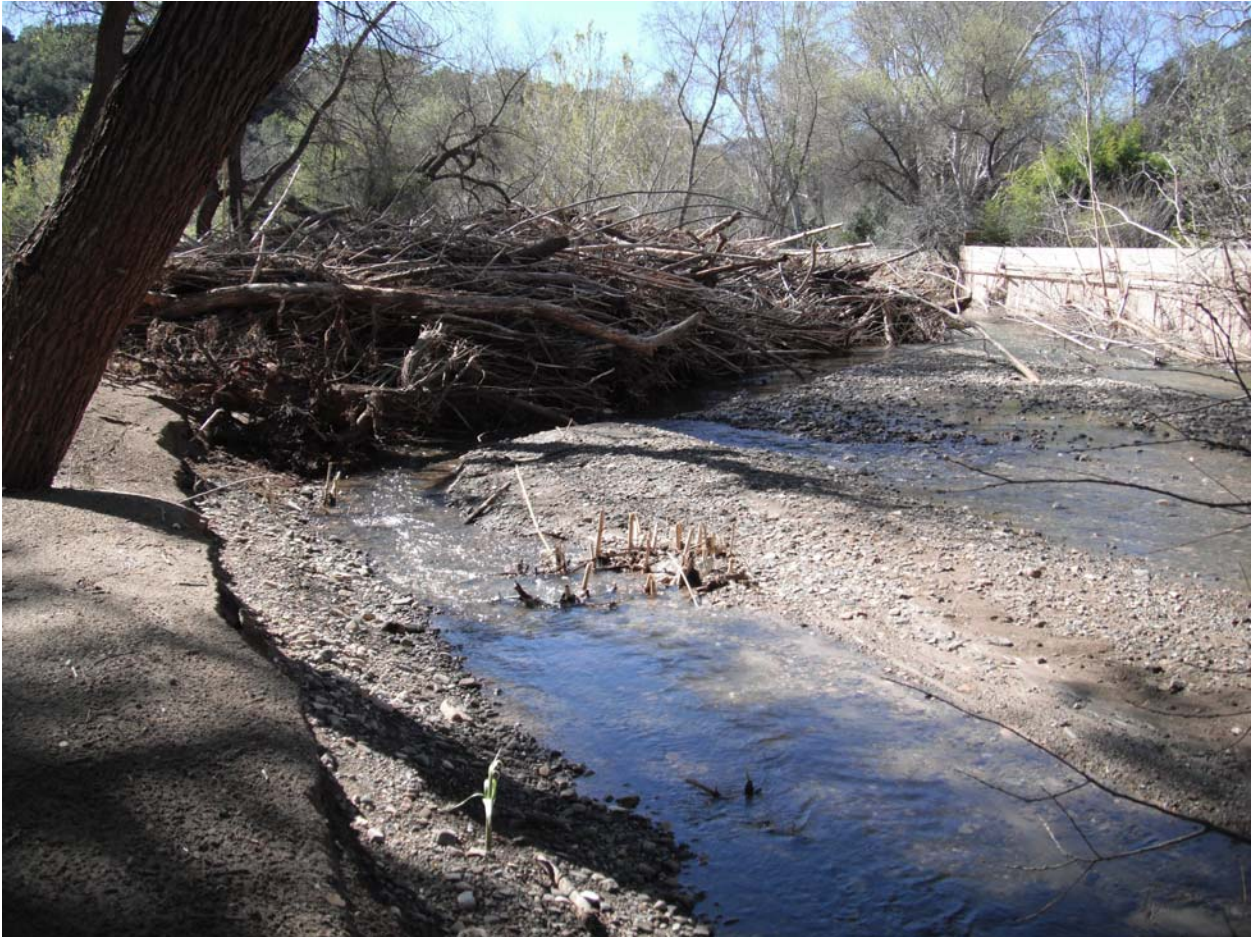
Debris jam on lower San Antonio Creek created during the 18 February 2017 storm. A 102 cm *Oncorhynchus mykiss* redd was observed downstream of the jam prior to the storm event on 14 Feb 2017.

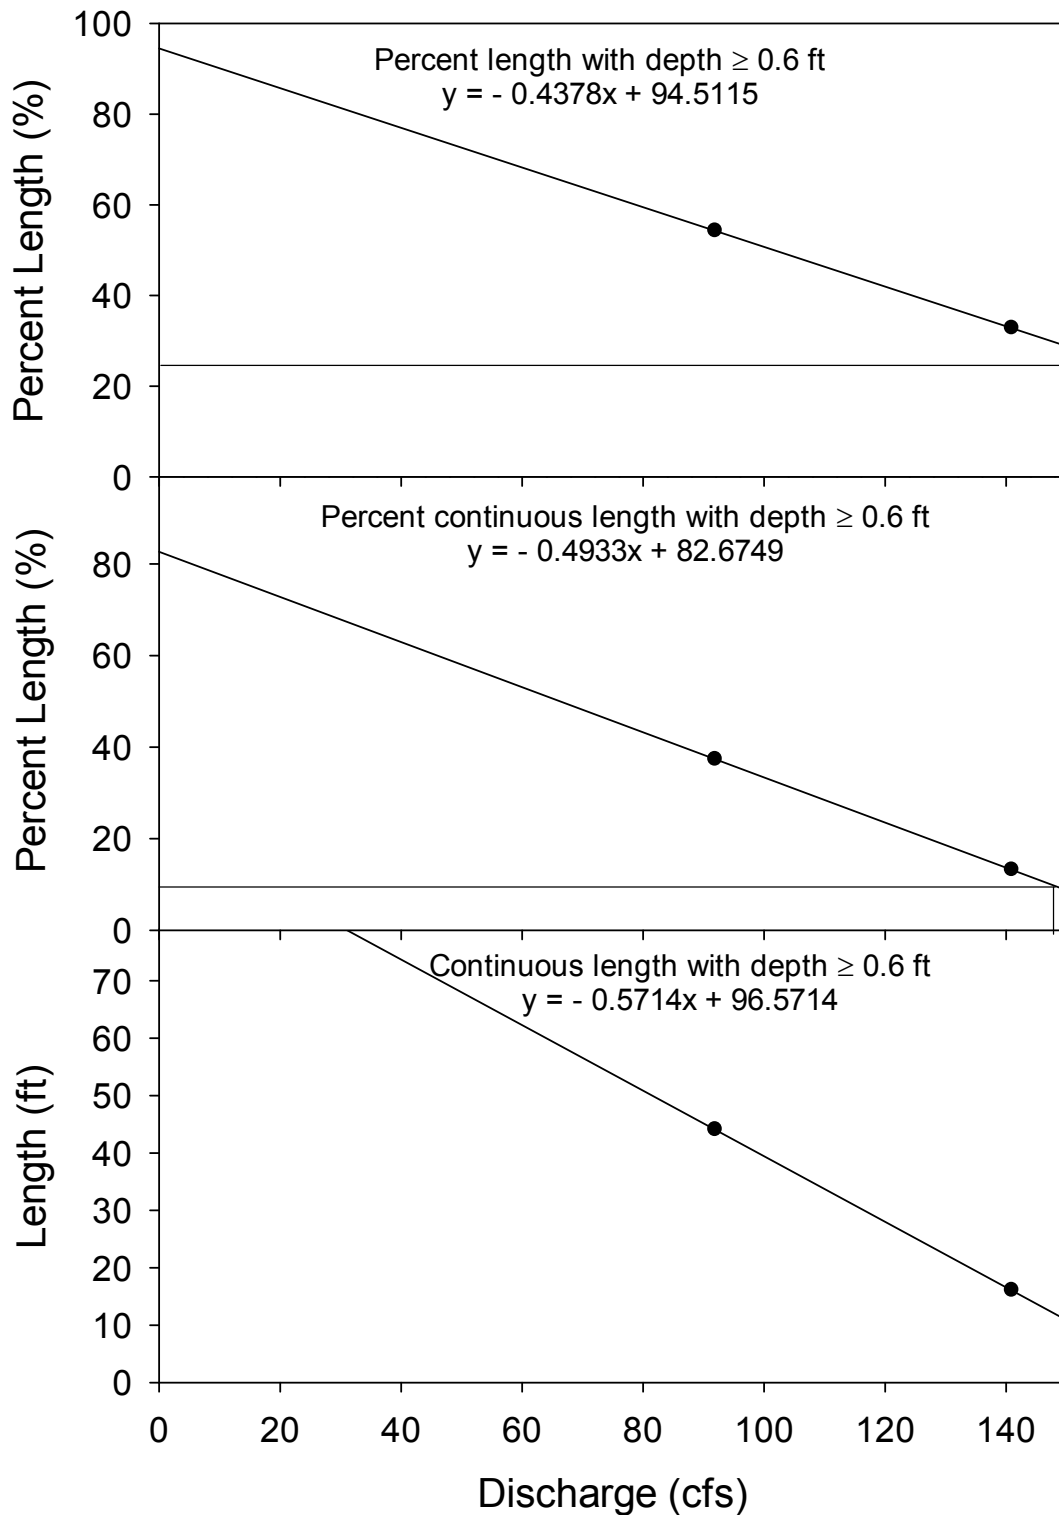
Appendix 5. Relation between Robles discharge and water depth at Site 5-2 downstream of Santa Ana Bridge and resulting discharge for various passage criteria.

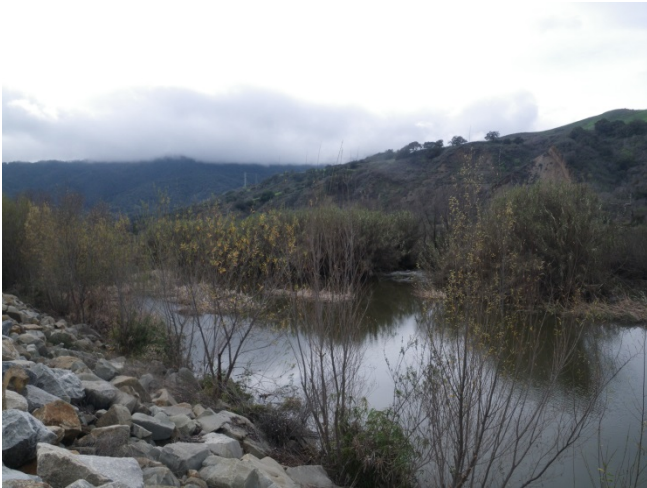
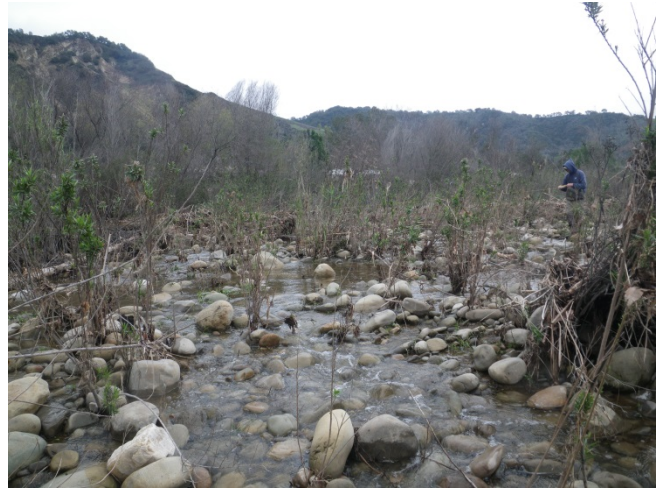
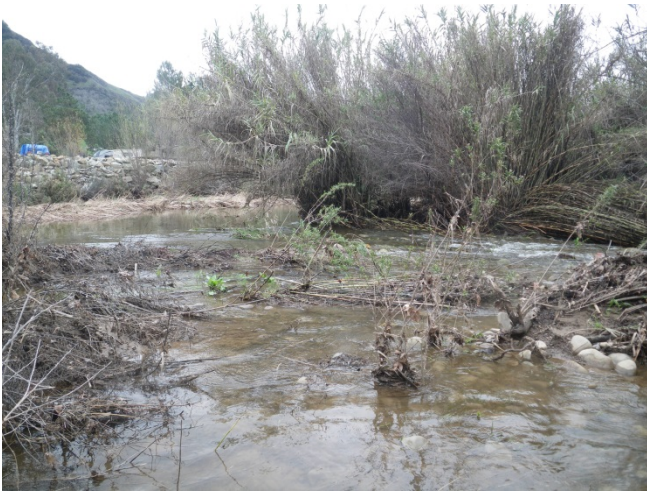
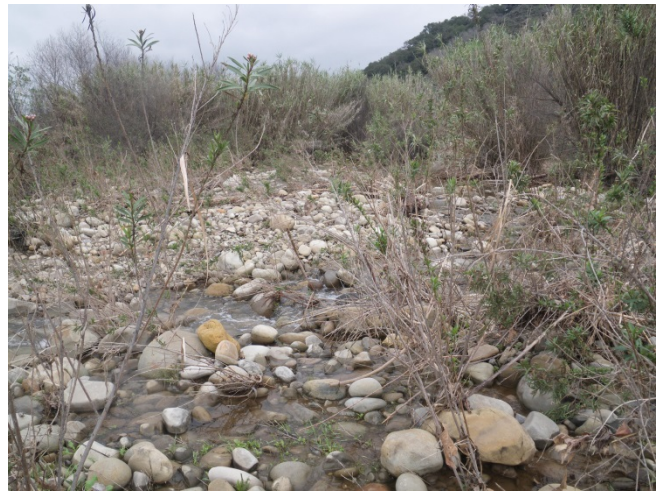
Appendix 13a. Photos of impediment Site 3-2 on February 8, 2017 during 50 cfs discharge release from Robles Fish Facility, looking from: (A) upstream, (B) downstream, (C) left to right bank, and (D) right to left bank.

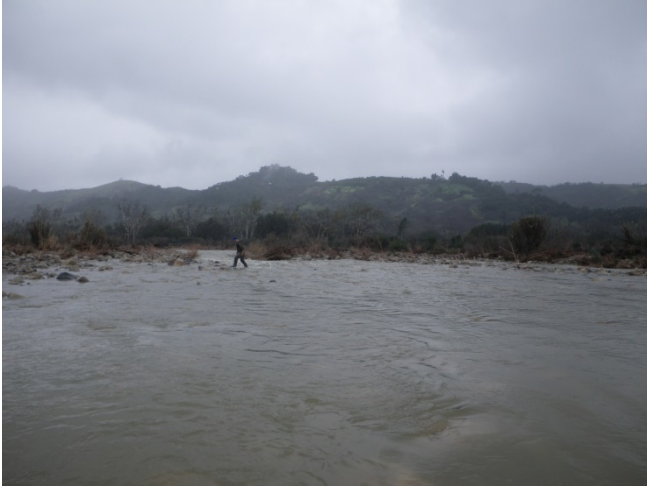
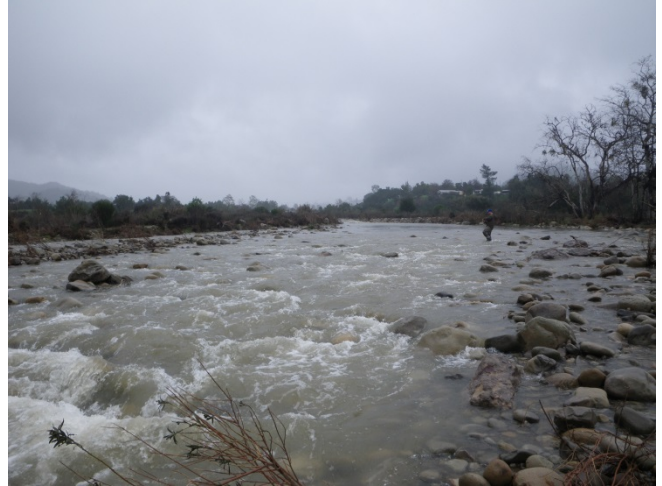
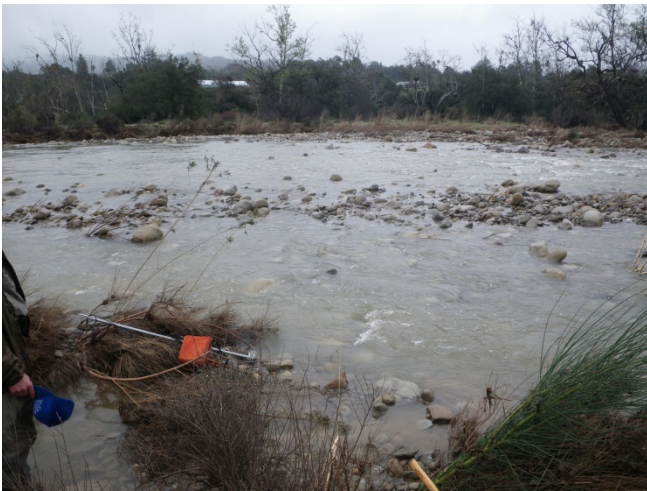
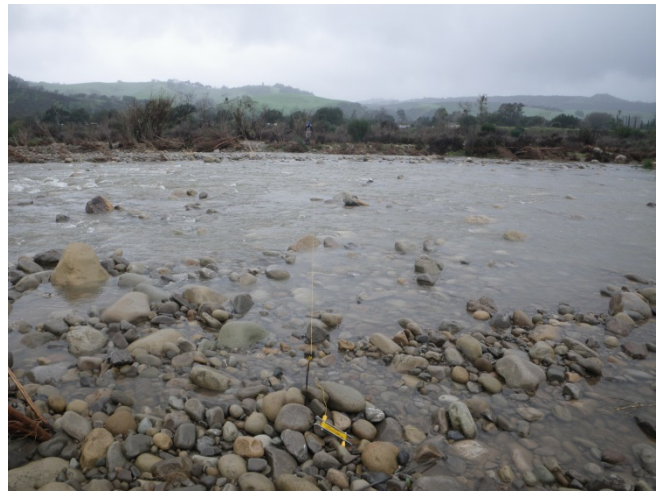
Appendix 13b. Photos of impediment site number 5-2 on February 20, 2017 during 74 cfs discharge release from Robles Fish Facility, looking from: (A) upstream, (B) downstream, (C) left to right bank, and (D) right to left bank.

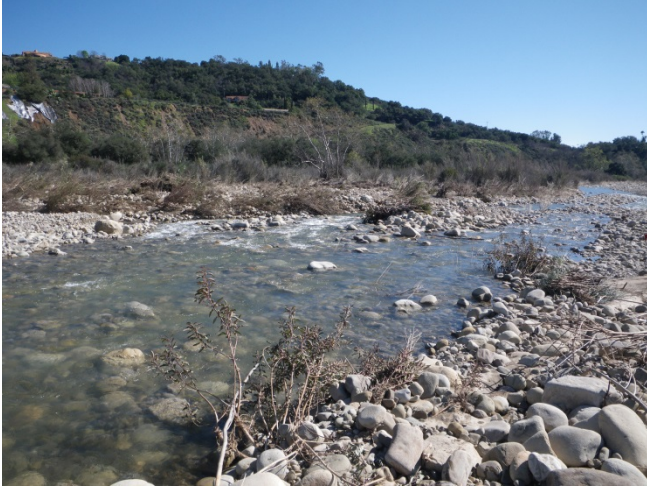
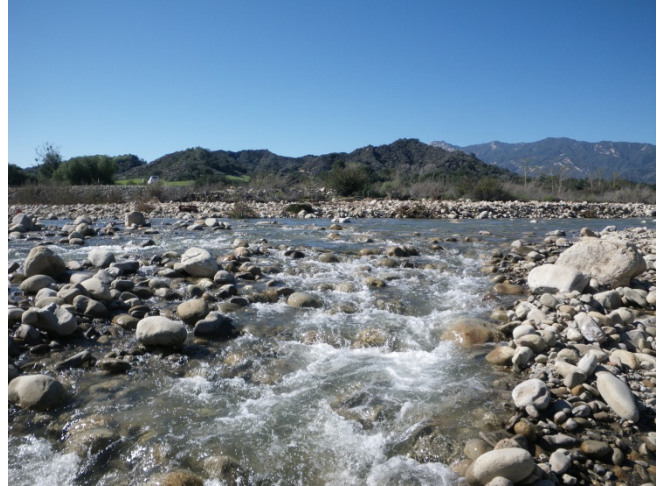
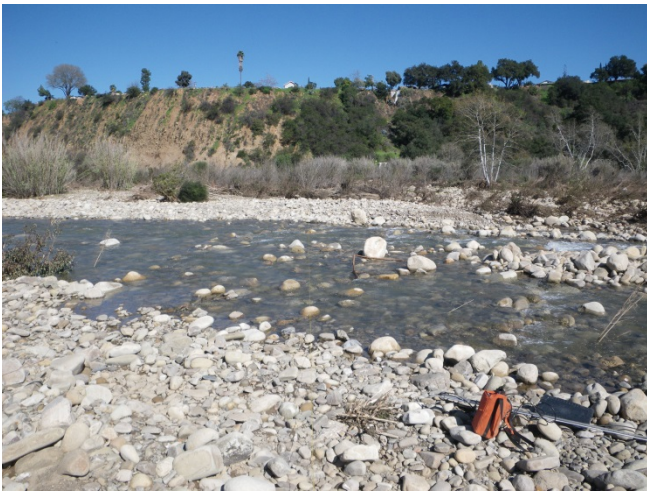
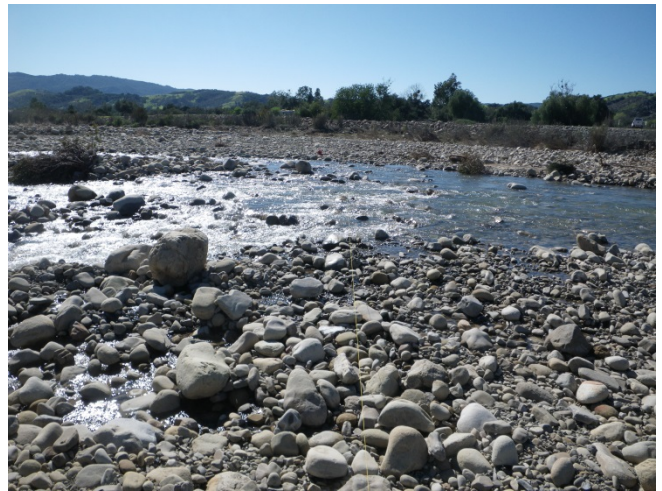
Appendix 13c. Photos of impediment site number 6-4 on February 24, 2017 during a 50 cfs discharge release from Robles Fish Facility, looking from: (A) upstream, (B) downstream, (C) left to right bank, and (D) right to left bank.

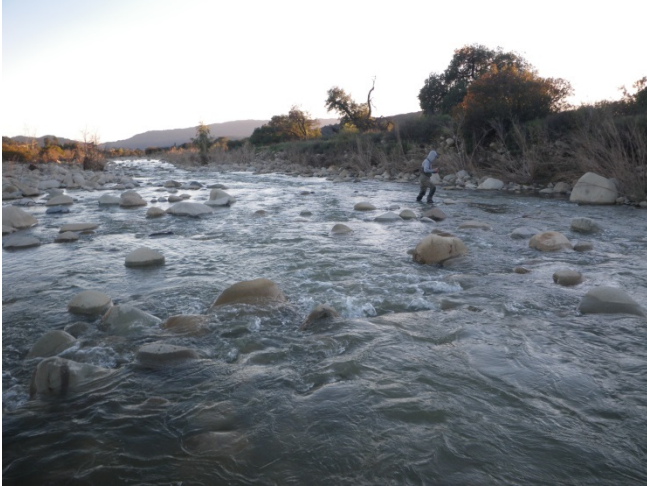
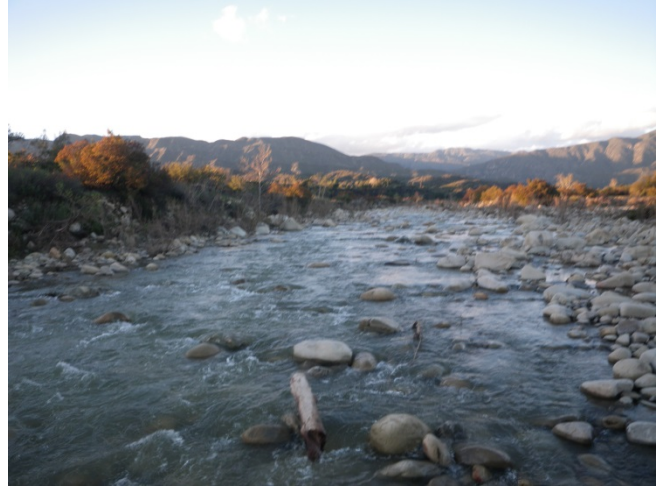
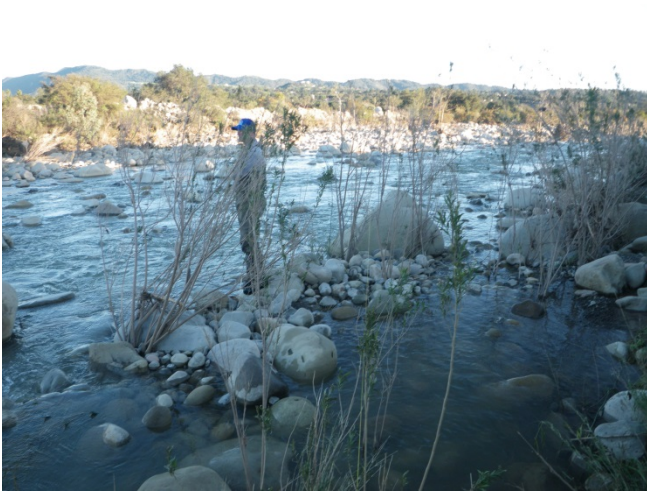
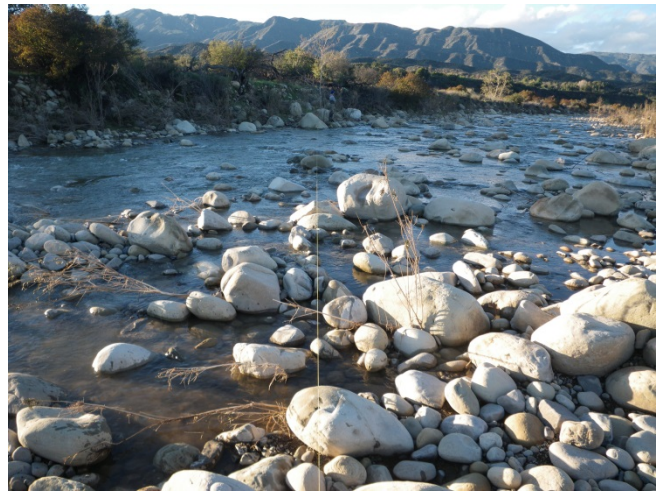
Appendix 13d. Photos of impediment site number 7 on February 22, 2017 during a 54 cfs discharge release from Robles Fish Facility, looking from: (A) upstream, (B) downstream, (C) left to right bank, and (D) right to left bank.

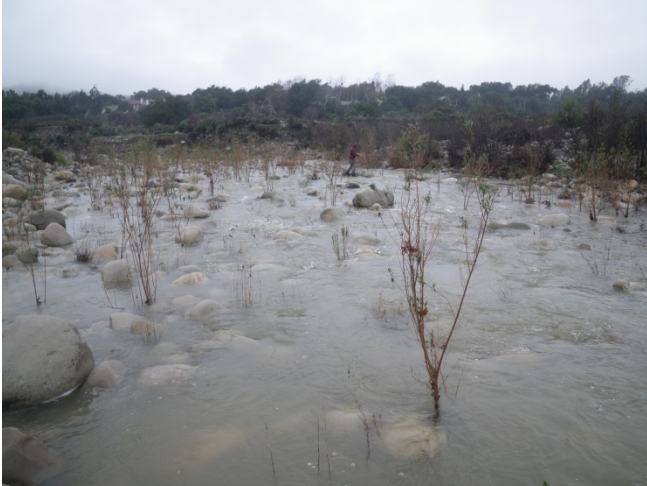
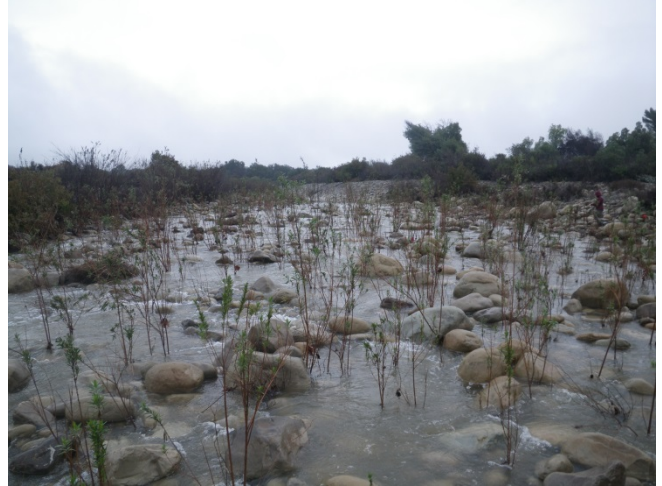
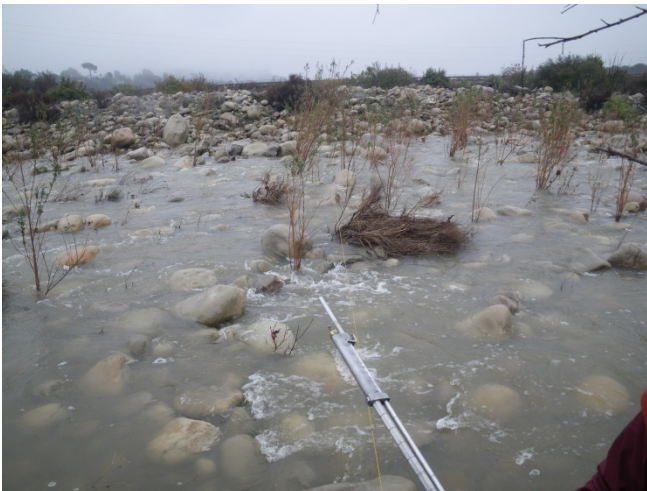
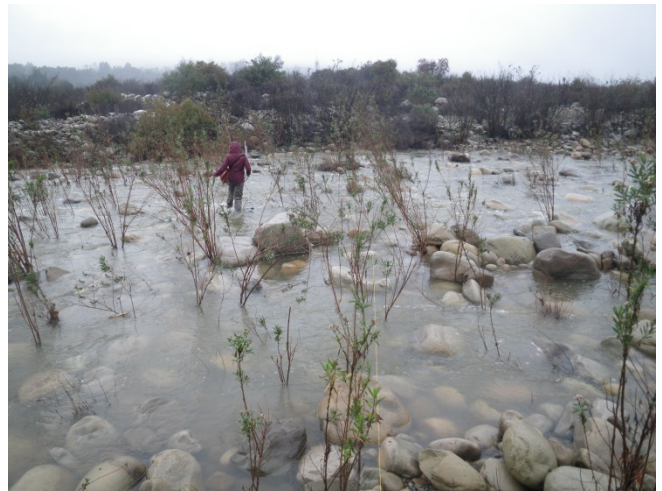
Appendix 13e. Photos of impediment site number 9 on February 7, 2017 during 50 cfs discharge release from Robles Fish Facility, looking from: (A) upstream, (B) downstream, (C) left to right bank, and (D) right to left bank.

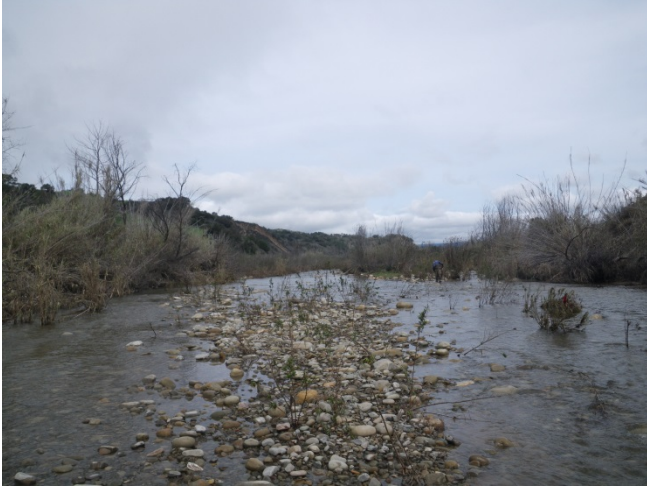
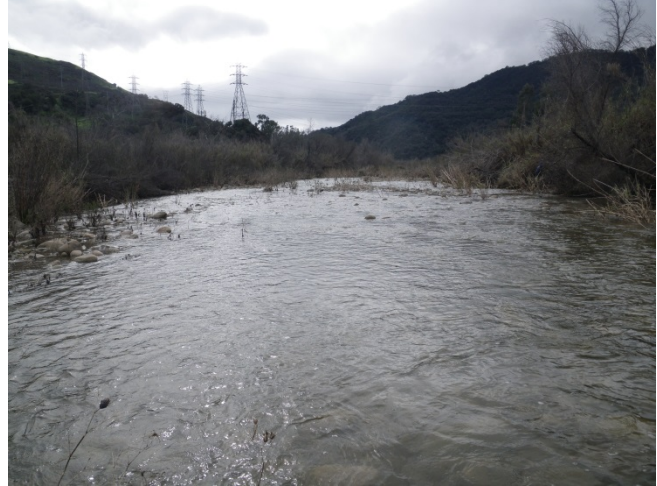
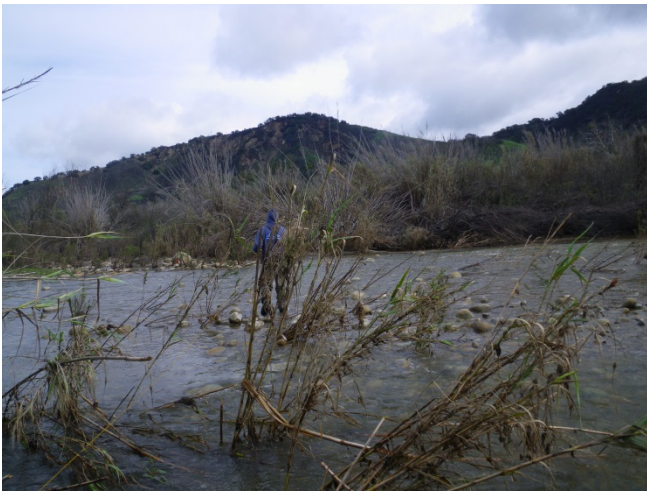
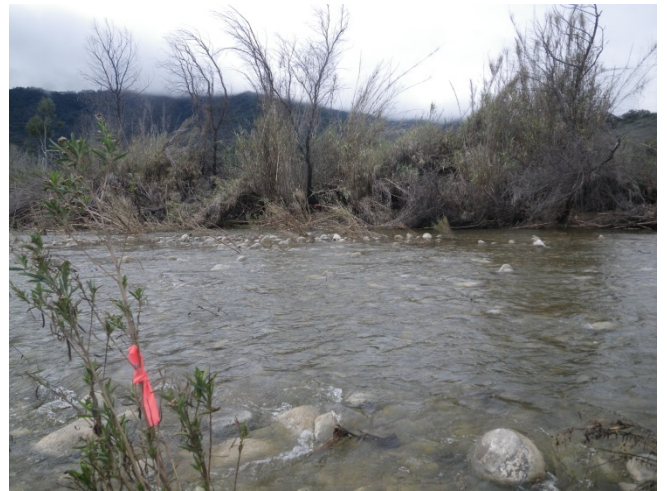
Appendix 13f. Photos of impediment site number 10 on February 8, 2017 during 50 cfs discharge releases from Robles Fish Facility, looking from: (A) upstream, (B) downstream, (C) left to right bank, and (D) right to left bank.

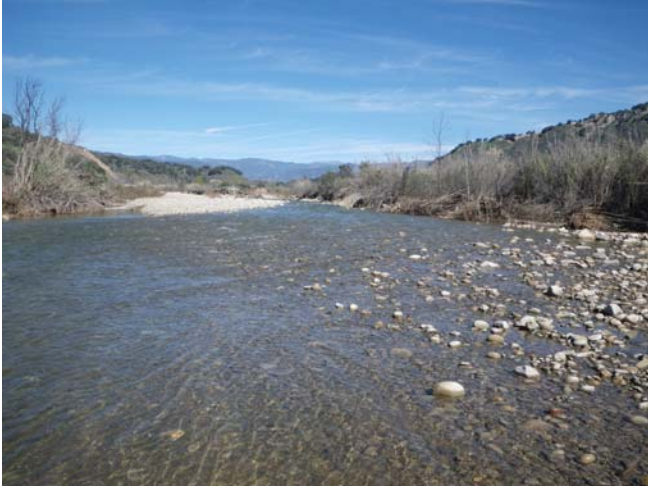
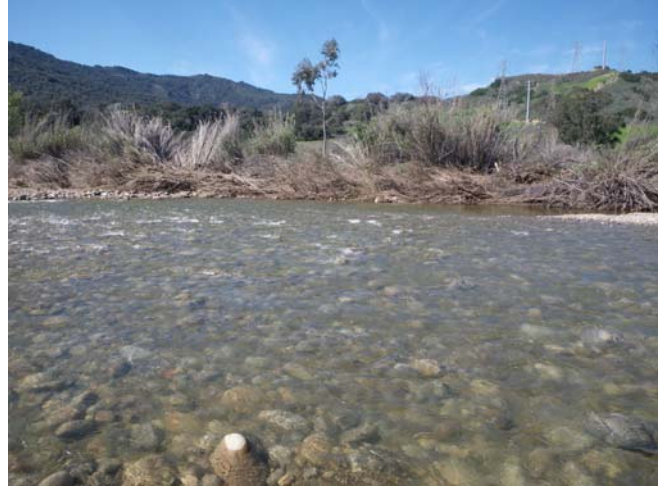
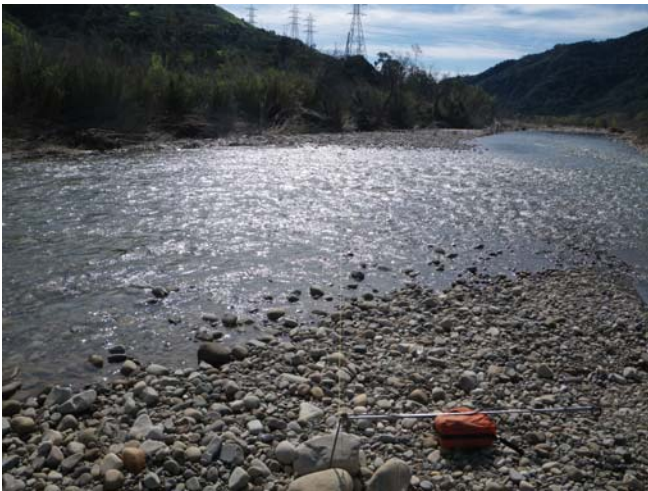
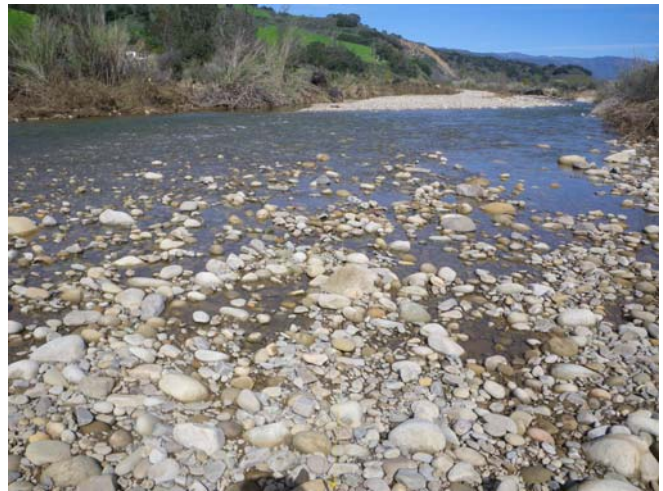
Appendix 13g. Photos of impediment site number 10-2 on February 24, 2017 during 50 cfs discharge releases from Robles Fish Facility, looking from: (A) upstream, (B) downstream, (C) left to right bank, and (D) right to left bank.

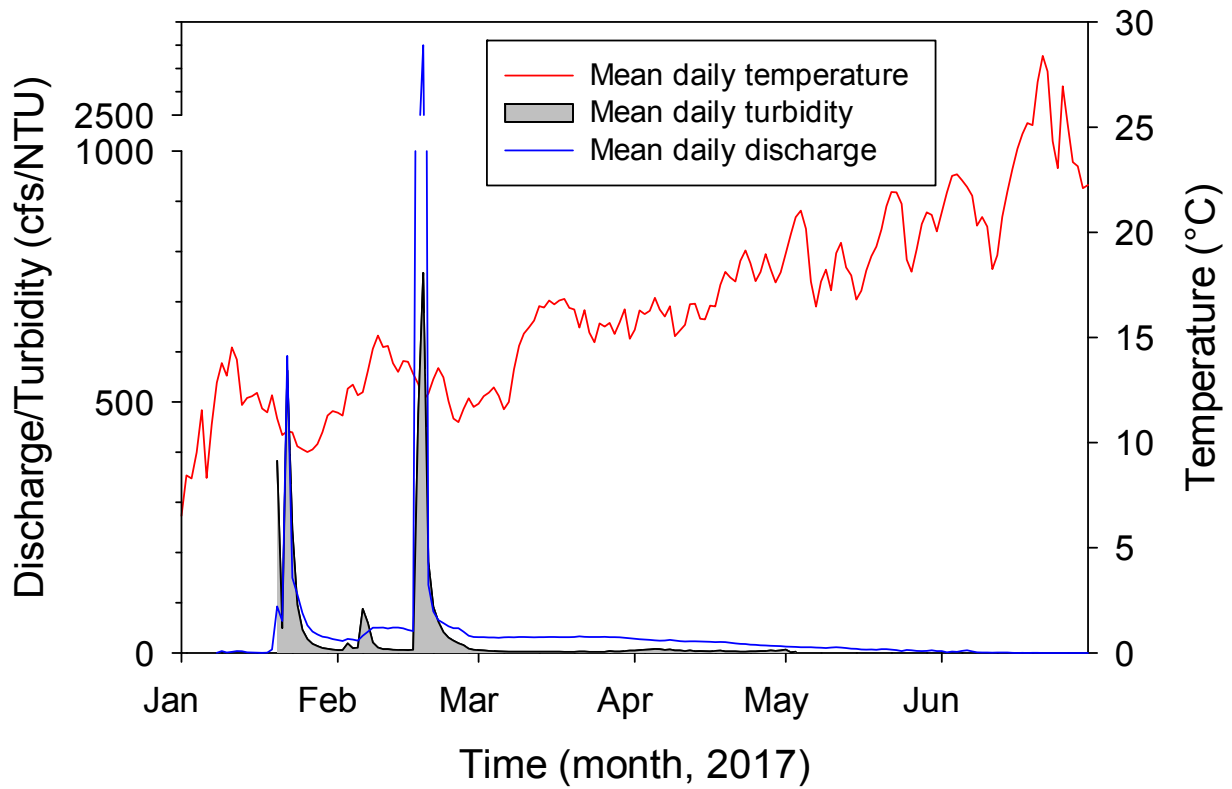
Appendix 19. Mean daily discharge, water temperature, and turbidity at the Robles Fish Facility during the 2017 fish passage season.

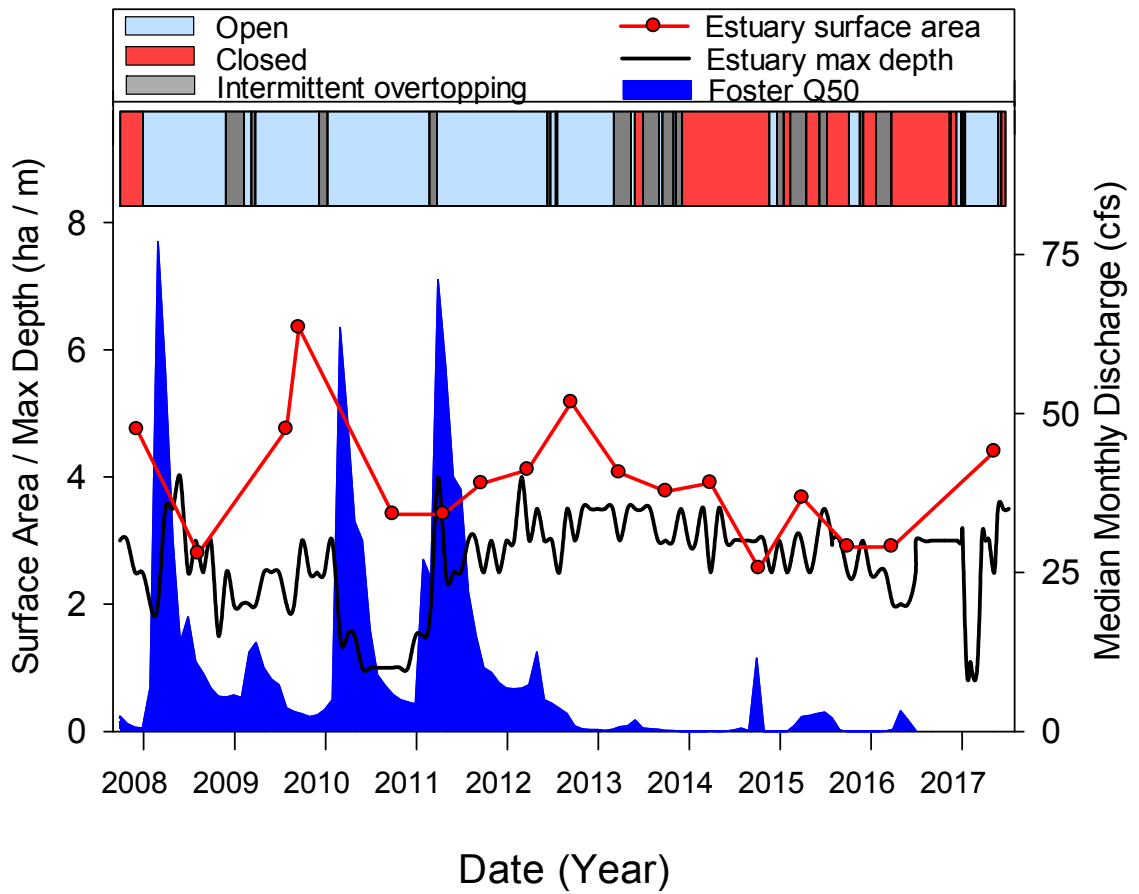
Appendix 29. Ventura River estuary/lagoon water depth, surface area, sandbar status, and discharge at Foster Park since 2008.

From 2008 through 2011, which were wetter years, the sandbar status and estuary/lagoon depth and size varied with conditions. However, since the beginning of the current drought in 2012, conditions have remained somewhat uniform (Appendix 29).

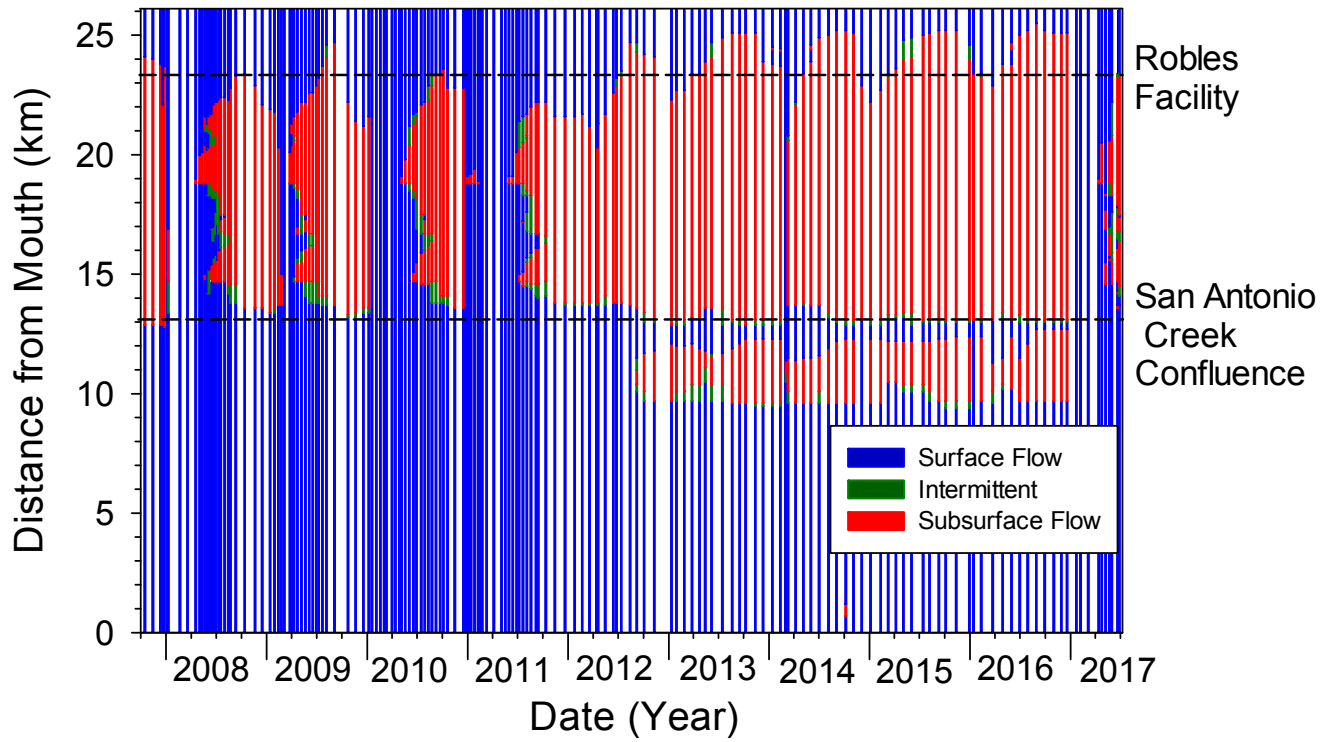
Appendix 30. Ventura River channel surface flow monitoring from 2008 to 2017.

The Ventura River, like most rivers in southern California, have significant reaches that lose surface flow during most years after storm flows recede. To quantify this natural pattern, surface flows have been observed and documented beginning at the end of 2007. Like the sandbar monitoring, clear patterns have become apparent. During normal precipitation years, there are typically surface flows throughout the length of the Ventura River mainstem during the fish passage season. Even during years of normal precipitation, the Robles Reach goes dry shortly after storms occur. However, beginning with the drought, the Robles Reach has been dry for extensive periods of time, even extending downstream of the San Antonio Creek confluence. This dry pattern was reduced significantly due to the precipitation and runoff during 2017 monitoring period (Appendix 30).
