2006 Annual Progress Report
of the
Robles Diversion Fish Passage Facility

Casitas Municipal Water District
1055 Ventura Avenue
Oak View, California 93022

November 2006

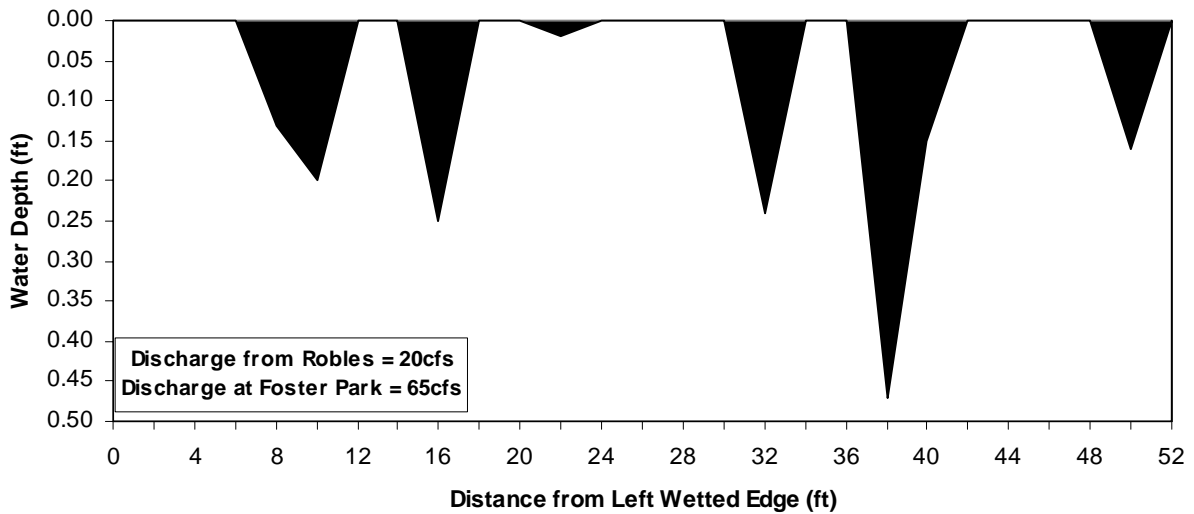
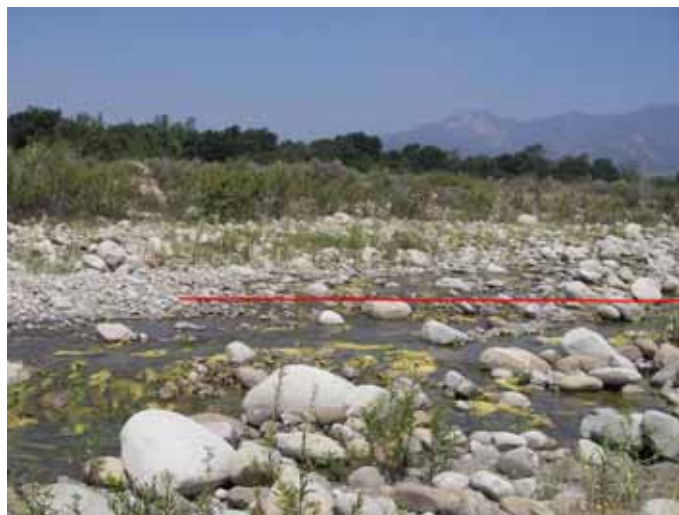
Appendix 1.1. Table, graph, and photo of transect 1.

Distance (ft)	Depth (ft)	Distance (ft)	Depth (ft)	Distance (ft)	Depth (ft)
0	0	18	0	36	0
2	0	20	0	38	0.47
4	0	22	0.02	40	0.15
6	0	24	0	42	0
8	0.13	26	0	44	0
10	0.2	28	0	46	0
12	0	30	0	48	0
14	0	32	0.24	50	0.16
16	0.25	34	0	52	0

Transect 1 (site 4 in Entrix 1999) was located just upstream of the HWY 150 bridge at approximately RM 11.5 and was about 2.5 miles downstream of the Robles Facility. The transect had a total of 28 depths measured across the wetted channel. Of those, only eight had a depth of water to measure, and the remaining were exposed. The depths of water measured ranged from 0.02 ft to 0.47 ft and represented approximately 30% of the measurements. The mean for the measured depths was 0.20 ft. The mean depth for the entire transect that included exposed areas was 0.06 ft. The Discharge of the Ventura River just downstream of the Robles Facility at the time of the survey was measured at 20 cfs and the discharge at the USGS gage near Foster Park was 65 cfs (Appendix 1.1).

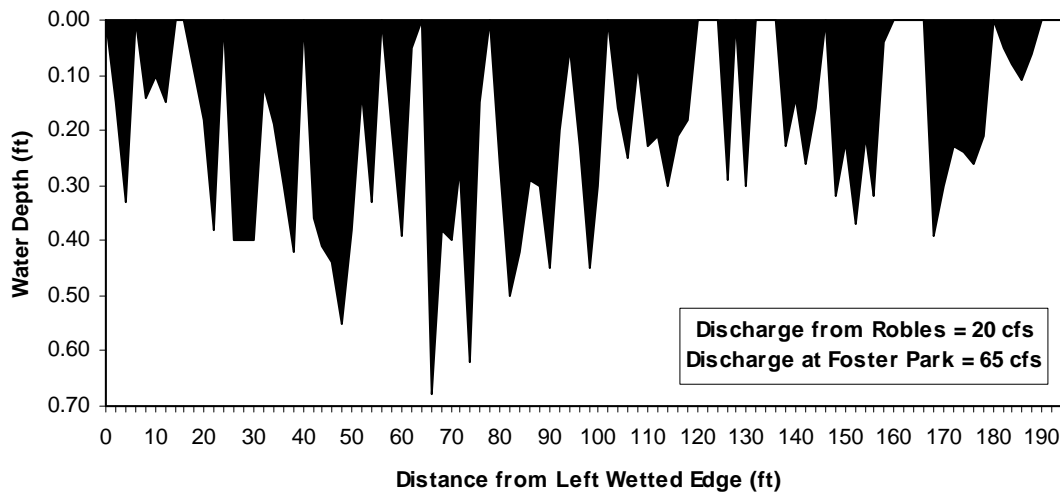
Appendix 1.2. Table, graph, and photo of transect 2.

Distance (ft)	Depth (ft)	Distance (ft)	Depth (ft)	Distance (ft)	Depth (ft)	Distance (ft)	Depth (ft)	Distance (ft)	Depth (ft)
0	0	40	0	80	0.26	120	0	160	0
2	0.15	42	0.36	82	0.5	122	0	162	0
4	0.33	44	0.41	84	0.42	124	0	164	0
6	0	46	0.44	86	0.29	126	0.29	166	0
8	0.14	48	0.55	88	0.3	128	0	168	0.39
10	0.1	50	0.38	90	0.45	130	0.3	170	0.3
12	0.15	52	0.13	92	0.2	132	0	172	0.23
14	0	54	0.33	94	0.05	134	0	174	0.24
16	0	56	0	96	0.23	136	0	176	0.26
18	0.09	58	0.2	98	0.45	138	0.23	178	0.21
20	0.18	60	0.39	100	0.3	140	0.14	180	0
22	0.38	62	0.05	102	0	142	0.26	182	0.05
24	0	64	0	104	0.16	144	0.16	184	0.08
26	0.4	66	0.68	106	0.25	146	0	186	0.11
28	0.4	68	0.38	108	0.08	148	0.32	188	0.06
30	0.4	70	0.4	110	0.23	150	0.22	190	0
32	0.12	72	0.27	112	0.21	152	0.37	192	0
34	0.19	74	0.62	114	0.3	154	0.21	194	0
36	0.3	76	0.15	116	0.21	156	0.32	196	0
38	0.42	78	0	118	0.18	158	0.04

Transect 2 (site 7 in Entrix 1999) was located just downstream of the Arroyo Mobile Home Park at approximately RM 7.5 and was about 6.5 miles down stream of the Robles Facility. The transect had a total of 99 depths measured across the wetted channel. Of those, 72 were able to have a depth measured and the remainder were dry. The depths ranged from 0.04 ft to 0.68 ft. The mean depth of the measured depths was 0.27 ft and the mean depth of the entire transect that included the exposed areas was 0.20. Discharge past the Robles Facility at the time of the survey was measured at 20 cfs and the discharge at the USGS gage near Foster Park was 65 cfs (Appendix 1.2).

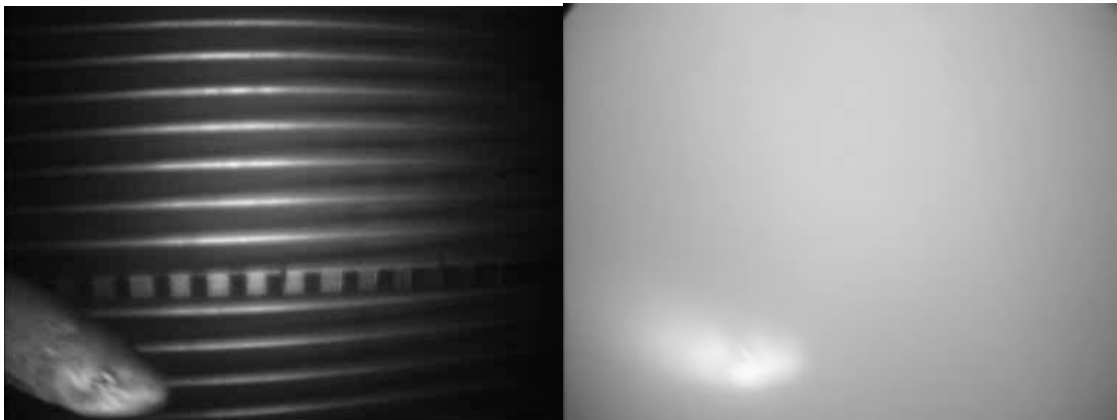
Photo 1. *O. mykiss* detected on 04-14-06 at 01:23 h and was estimated to be 31 cm.

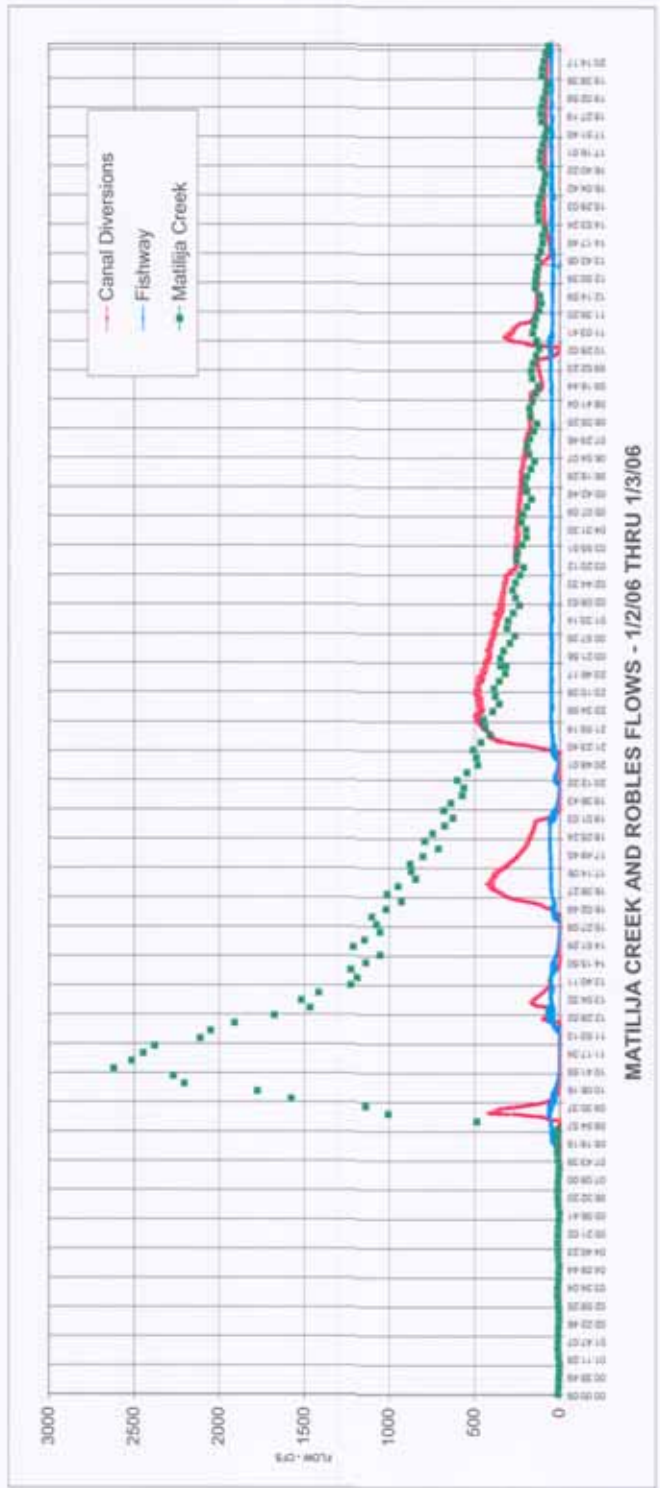
Figure 1 - Storm Event of January 2 thru 3, 2006

(Note that North Fork flow conditions are not included for total inflow into Robles)

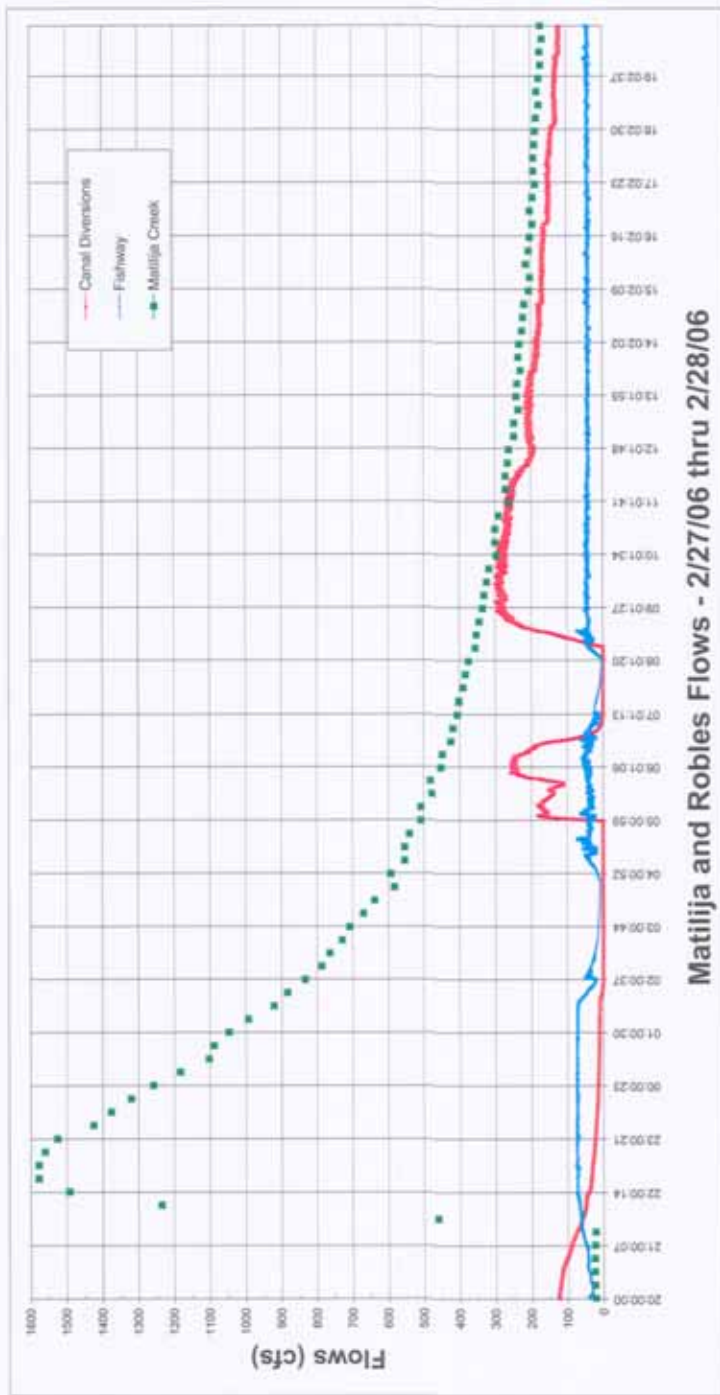
Figure 2 - Storm Event of February 27 thru 28, 2006

(Note that North Fork flow conditions are not included for total inflow into Robbles)

As of approximately 0300 hours on 2/28/06, flow conditions peaked in the upper Matilija Creek and North Fork Matilija Creek. Matilija Dam began to spill at this point in time and crested at approximately two feet over spill. The facilities at Robles Diversion Dam were set to allow a 50 cfs flow thru the fish ladder and divert all other excess up to 500 cfs down the canal. The flows entering the Robles basin did exceed 550 cfs (an initial estimate of >2000 cfs) and overtopped the cutoff wall. Diversions were reduced greatly during this time due to the leaf litter gathering on the face of the screens. The facility was dewatered between 0630 to 0930 hours to remove leaf litter.

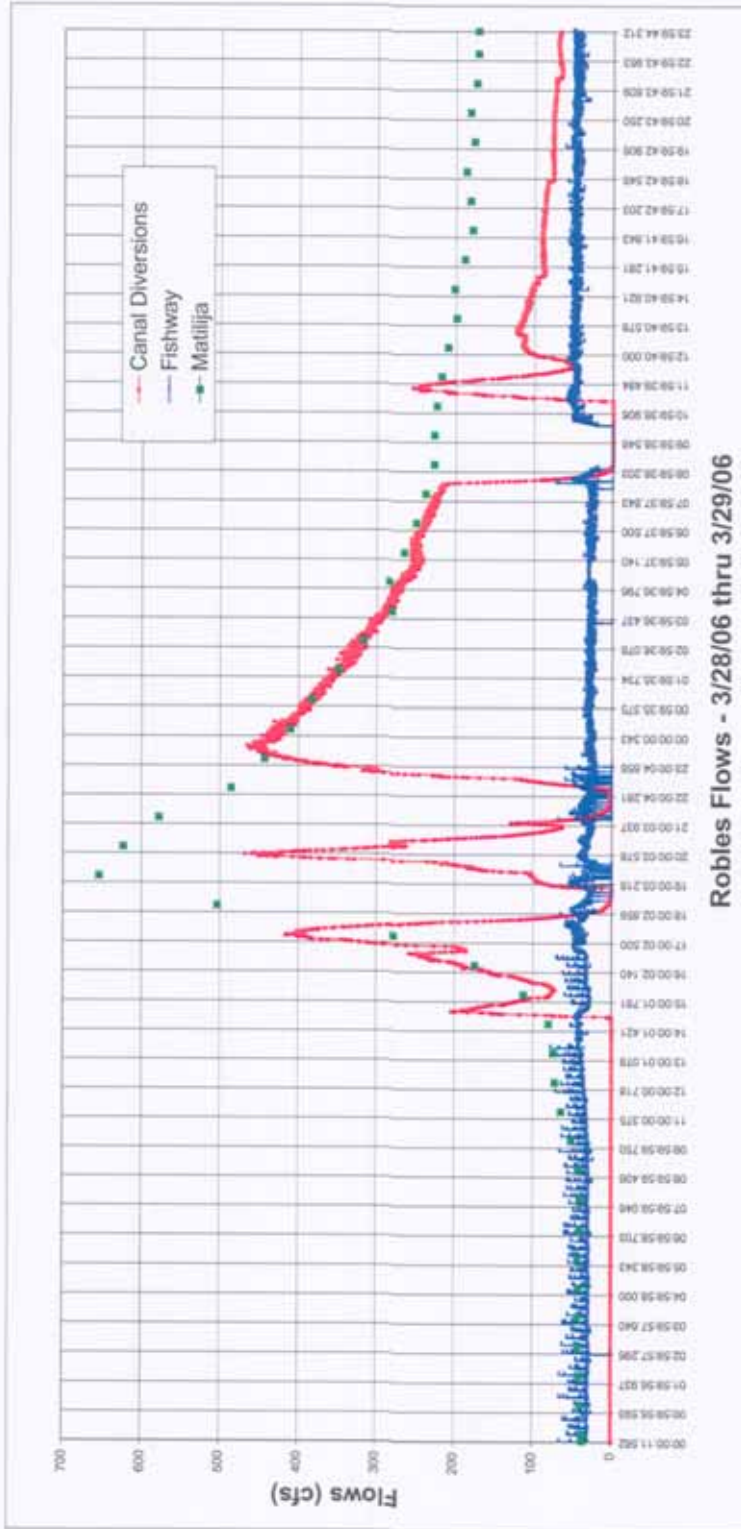
Figure 3 - Storm Event of March 28 thru 29, 2006

(Note that North Fork flow conditions are not included for total inflow into Robles)
